POST-IRRADIACION EXAMINATION OF U_3Si_x -AL FUEL ELEMENT MANUFACTURED AND IRRADIATED IN ARGENTINA

Gabriel Ruggirello, Hector Calabroni, Miguel Sanchez
Comisión Nacional Energía Atómica.
Argentina

Abstract

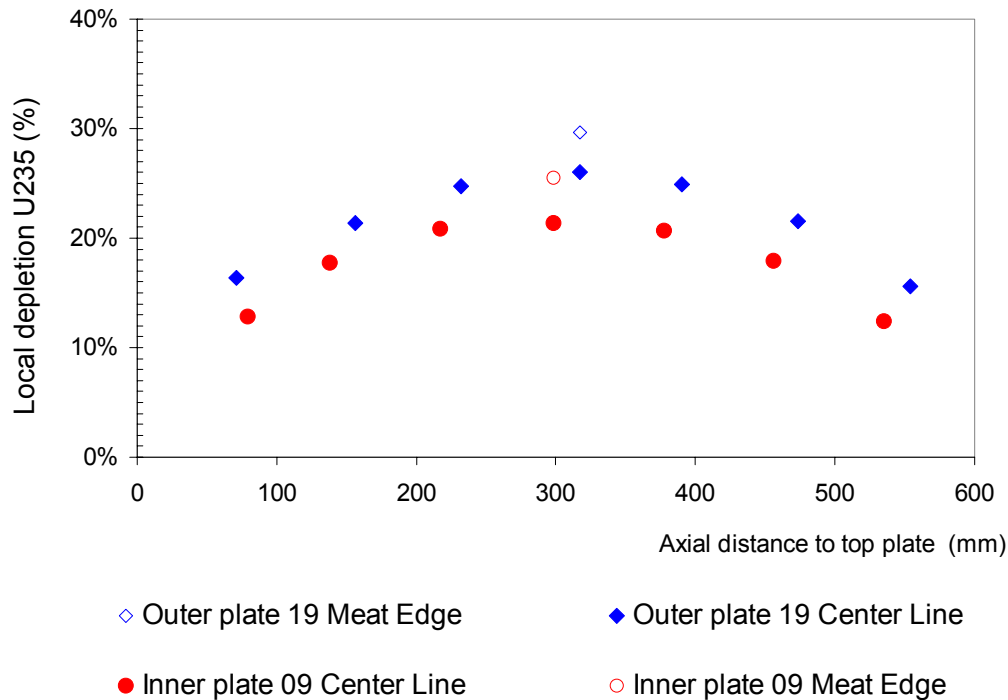
Figure No 7 Bu distribution

The samples were processed by the acid dissolution and ion-chromatographic separation [6]. The isotopic analysis was performed on an appropriate aliquote of the solution. The termo-ionization mass spectrometric were used [7], calibrated with U235 15% enriched standard (U-150 NIST). Isotopic composition of U was determined to evaluate the local depletion of U235 as Bu indicator. Figure No 7 shows the Bu distribution in both plates. A differences of 22% in U235 local depletion was found between the midcenter samples of the middle inner and outer plates. A similar relative difference was observed with the edge of the meat. These variation show the influence of the neutron thermalization distribution in the RA-3 reactor fuel.

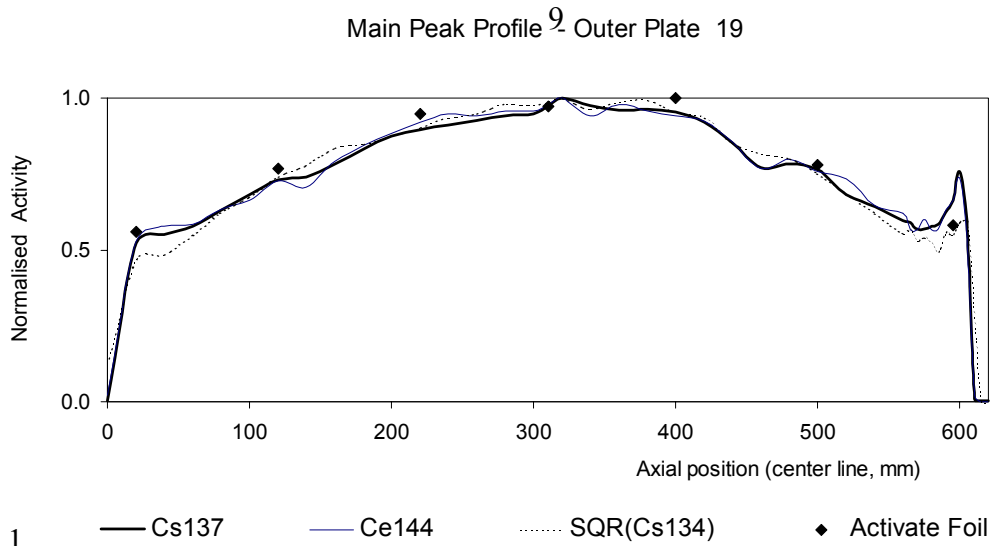
Figure 1

For any desired peak both profiles, axial and transverse, can be obtained from the net area under the corresponding peak in each measurement. Figure N° 1 shows, for plate N°19, the gamma activity axial profile normalised with respect to the maximum value for the three nuclides mentioned above. The square root of the Cs134 activity accounts for the fact that a double neutron capture is needed for its formation. This figure also includes the normalised values of the axial thermal neutron fluxes measured during irradiation of P04, obtained by the foil activation method [3]. A good agreement between the profile shape and the foil activation data is observed for all the nuclides.

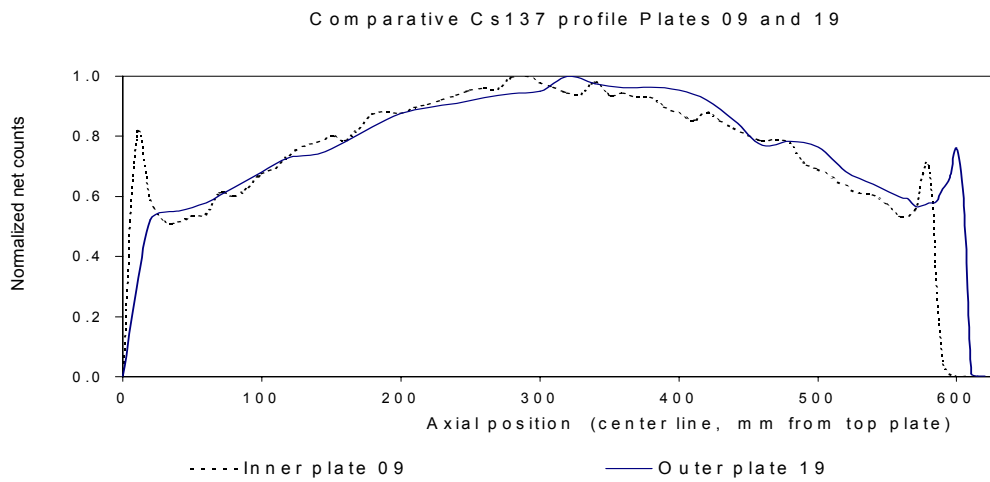
Figure 2

Figure N° 2 shows the Cs137 activity axial profile for both plates, normalised to the maximum value. The meat position along the length of the plate can be clearly seen, as well as a very significant effect of active material accumulation done during the manufacturing of the plate, “dog boning effect” at the both plate ends, which is shown by large activity peaks. It is consistent with the maximum area loading of about 28 % estimated for the manufacturing process of these plates. In other hand, the fact that this effect could be detected in a very narrow zone, indicates the effectiveness of the collimating arrangement.

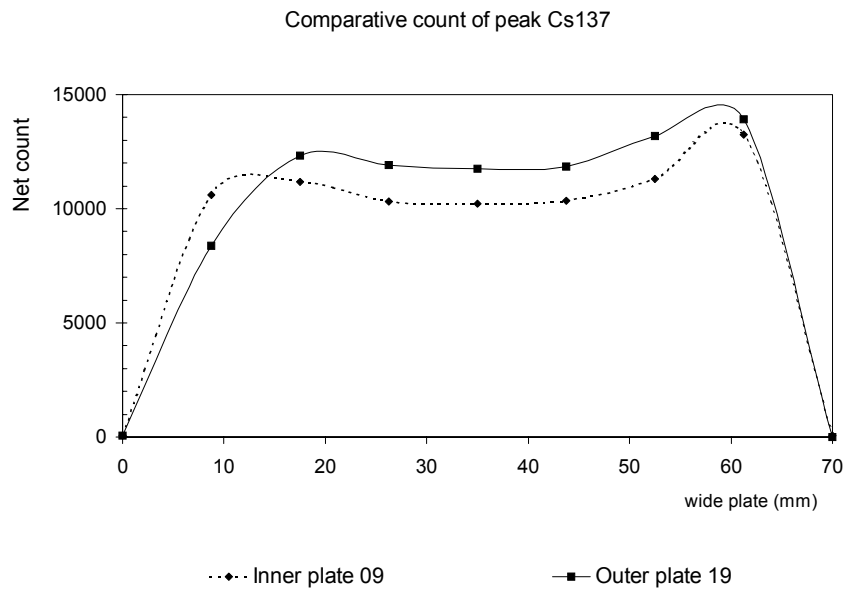
Figure 3

Figure N° 3 shows the Cs137 activity transverse profile at maximum axial activity for both the inner and the outer plates, in comparative counts for the same counting conditions. The end peak effect caused by the different neutron thermal flux into the assembly box, from the edge to the centre of each plate and from the outer to the inner plate, is clearly noticed.

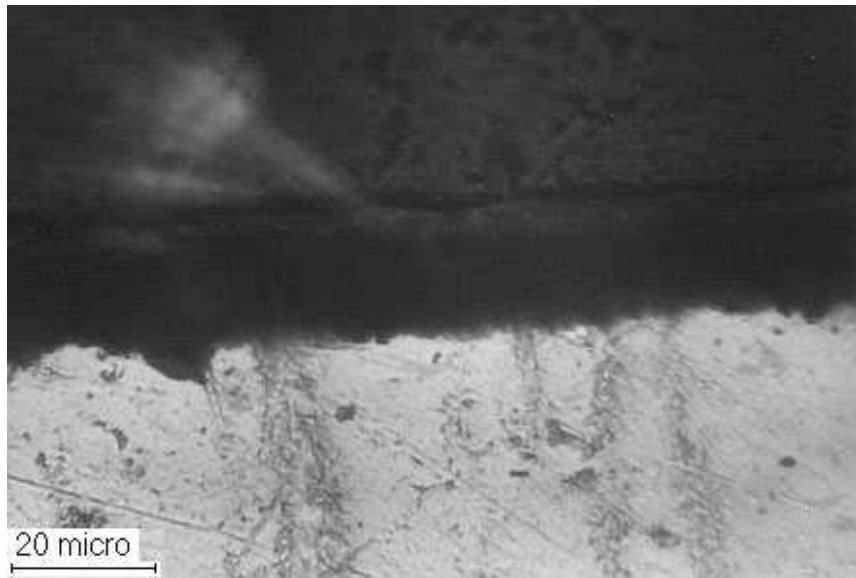
Clearly at mid center of the plate the oxide layer was the thickest where plate reach the maximum power density of about 30 Watt/cm^2 and the maximum cladding surface temperature aprox. 100 $^{\circ}\text{C}$. Figure No 4 shows cross-sectional views of the oxide layer observed at midcenter of the plate and in the bottom part of the unfuelled frame.

Figure No 4: cross-sectional views of the oxide layer observed at midcenter of the plate (a) and in the bottom part of the unfuelled frame (b).

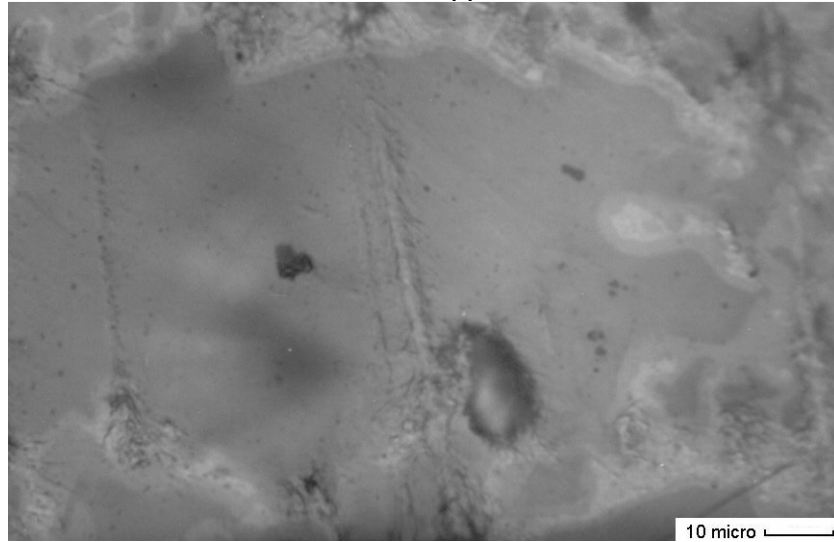
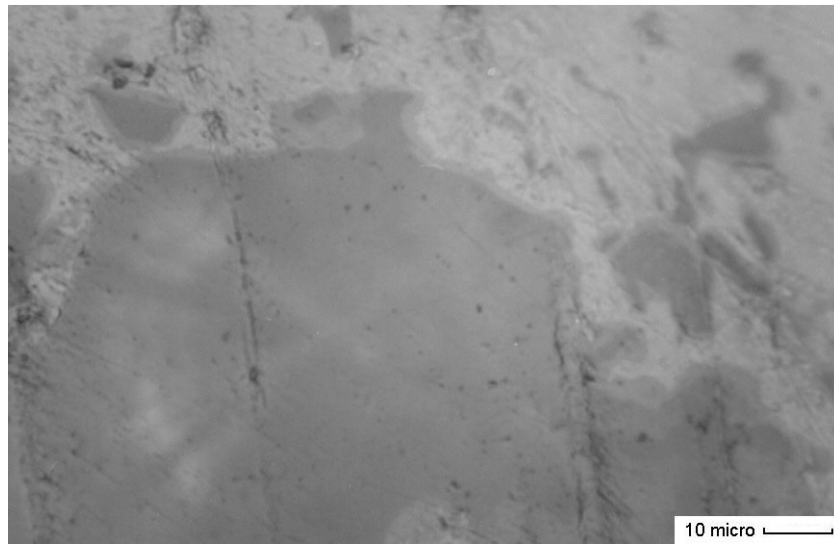
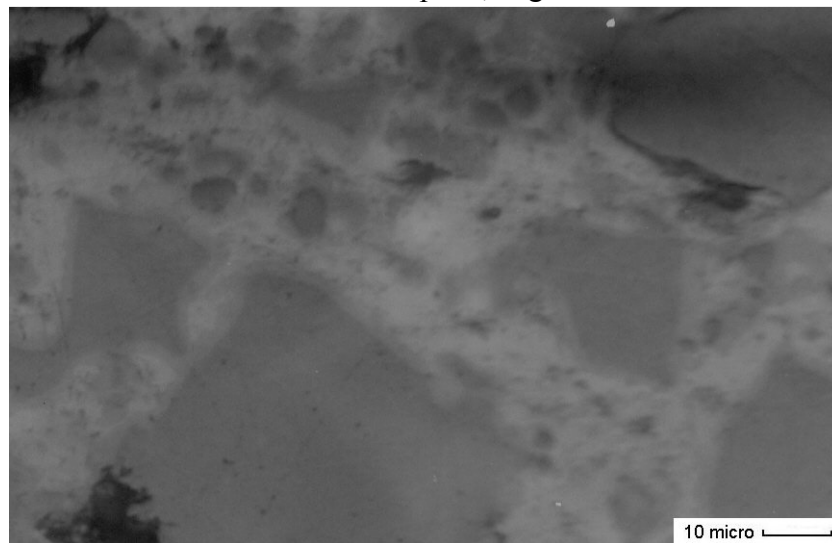
Figure N° 5 Micrographs of inner plate No 8.

The main objective was develop the methodology for the polishing of the sample and measurement of the interaction layer between the aluminium matrix and fuel particle. At the maximum burnup location, the typical thickness of interaction layer was 1.5 μm . Taken in account low Bu and thermal density of power, the temperature gradient in the cross section of the plate is rather small, and thus, the interaction zone is rather uniform in any position of the meat and primarily only a function of burn up. See Figure No 5 shows micrographs from different part of the inner plate 8.

The fuel particule swelling was determined by measuring the residual, as fabricated porosity on the micrographs, and from the immersion volume values mentioned in Section 3.3. A value of approximately $15\% \Delta V^F/V_o^F$ at the peak burnup location of plate No 8 corresponding fission density (FD) on fuel of $1.5 \times 10^{27} \text{ fis.m}^{-3}$, was thus found and is compared with previous experimental swelling data on U_3Si_x [4] and [5].

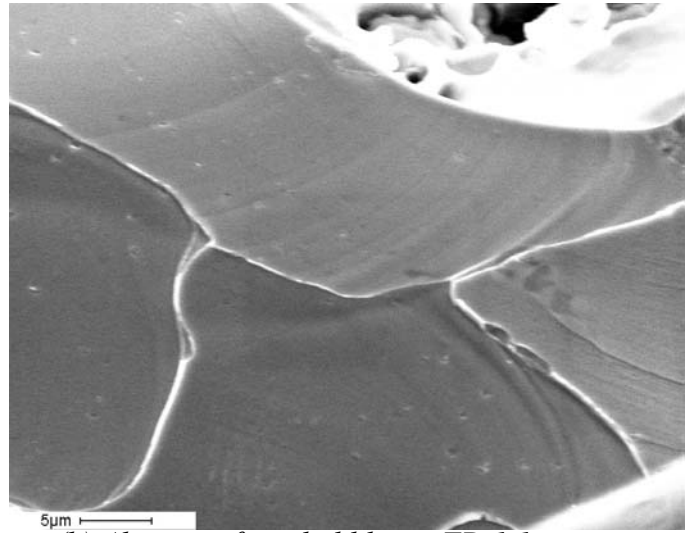
No observable gas bubbles in the bottom sample of the plate where the local Bu was 15.6% (FD: $1.1 \times 10^{27} \text{ fis.m}^{-3}$).

(b) Absence of gas bubbles at $FD 1.1 \times 10^{27} \text{ f.m}^{-3}$

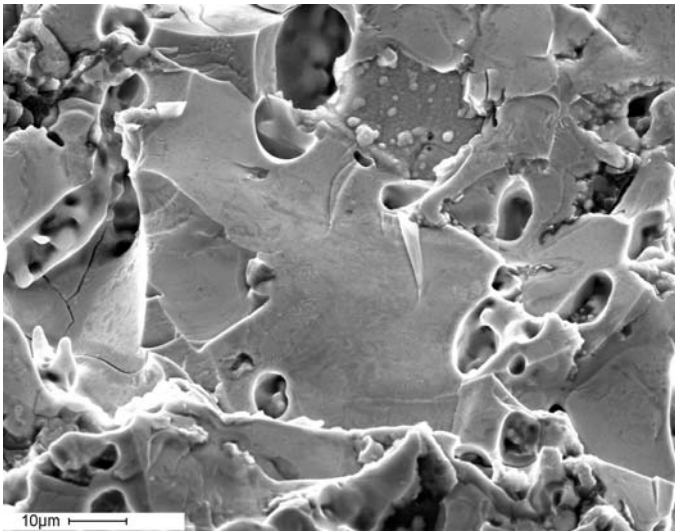
(c) Meat microstructure showing rounded as-fabricated porosity

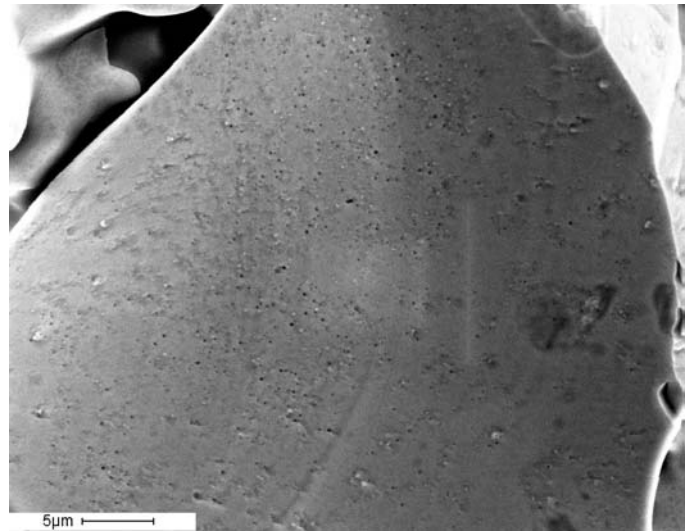
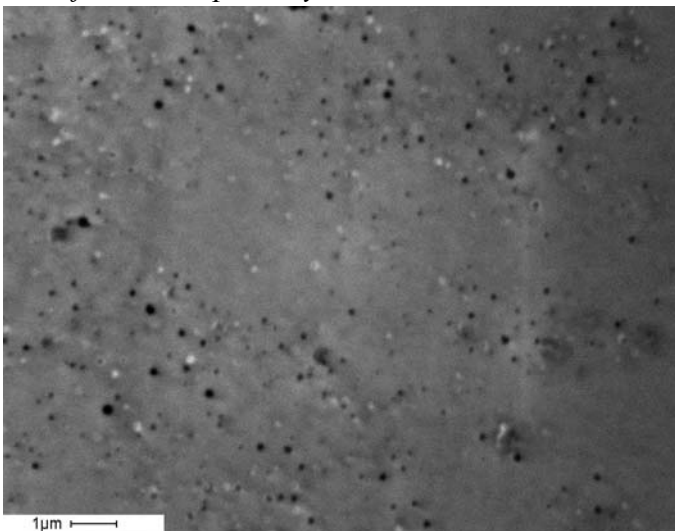
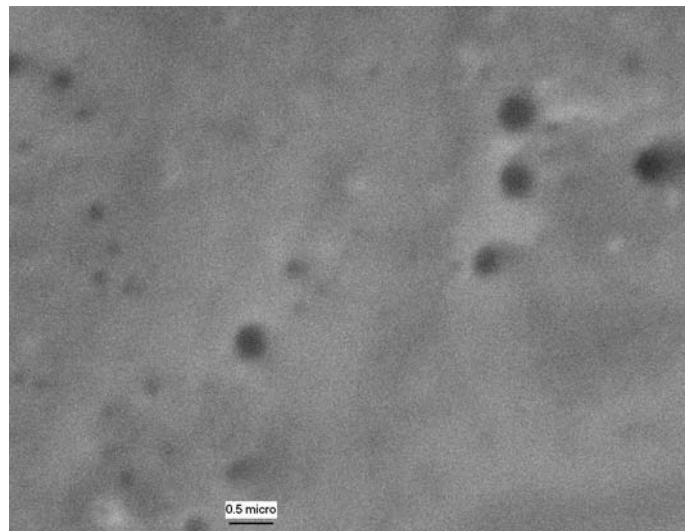
Samples for examination of fuel fracture surfaces by Scanning Electron Microscopy were obtained from the outer plate No 19 at the mid-center corresponding the maximum Bu and power of the element and in the bottom fuelled part of the plate away from the dog bone area. The entire sample was split in two halves by a micro nippers, obtaining a clean fracture surface of the fuel particles. The sample at midcenter where the local Bu was 26 % U235 depleted (FD: $1.7 \times 10^{27} \text{ fis.m}^{-3}$) shows small fission gas bubbles in the fuel particles. Typically the bubbles are 0.1 to 0.3 μm in diameter and the number density of bubbles in most of the fuel particles was low to negligible in other particles. This particle to particle variability in visible gas bubbles is likely due to the presence of two different phases (U_3Si and U_3Si_2) in this P04 fuel compound. This is further shown in Figure 5, where the bubbles appear to be confined to the lighter (more dense) phase in the particles, this being U_3Si .

(d) (e) and (f) Bubbles morphology at $FD 1.7 \times 10^{27} \text{ f.m}^{-3}$.

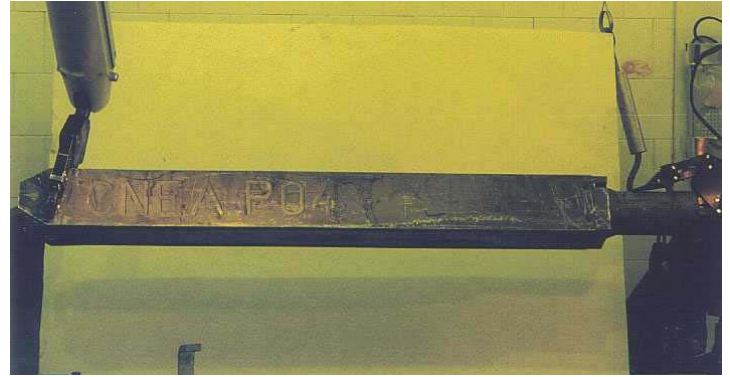
The elements were examined visually through the cell window with the help of a magnification glass and a telescope. The outer appearance of P-04 was as in the as-fabricated condition, with the exception of the oxide film and several handling marks. No abnormal features were observed. Photographs 2 shows the external state of P04.

Photographs 2: external state of P04.

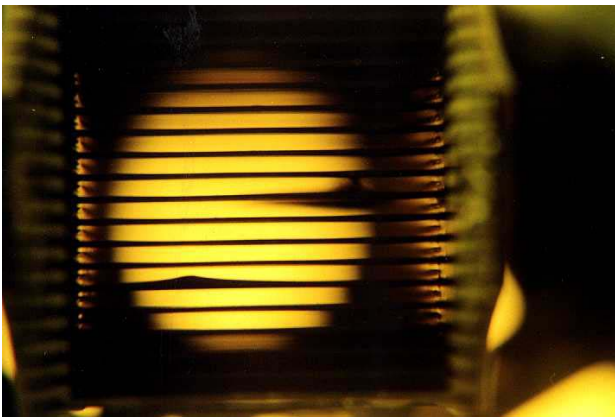
Photographs 3 shows the view through coolant channels after the removal of the handling bar, focussing on the upper part of the assembly. The bottom plate of the stack corresponds to the plate located at slot number 1. The plate at the 6th slot shows a small dent in its upper edge, caused by an impact made during the fuel element handling at the pool. The plate located on slot number 10, which is situated just below the handling bar, showed a leaking blister, convex on both sides of the plate, of approximately 3 cm in diameter. This defect was responsible of the fission product release detected in the reactor pool, that led to the decision of ending the P-04 irradiation. This failure was clearly identified as caused by damage done on this plate during the assembling of the element. The analysis of this failure will not be discussed in the present report, as it does not relate to the behaviour of the fuel element, however it will be the subject of another report regarding the degradation of defective Si-based dispersion fuel.

Photograph 3: view through the coolant channels after the removal of the handling bar. Defective blister in plate Nro 10.

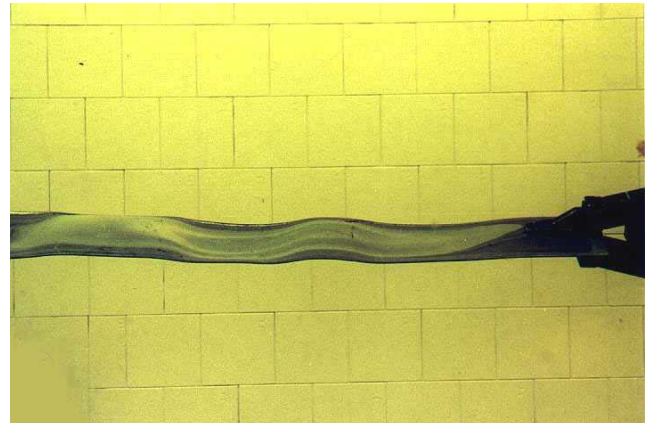
In plate N° 1, the test was continued up to 575 °C. This plate still remained free of blistering but the warping was very extensive in the meat zone. Photograph 6 shows expanded meat zone while the frame remained flat (metallographic observations will be done to study the transformation occurred in the meat at this temperature). Even in this condition of high stress and strain the meat-clad bonding resisted perfectly and no cracks or fissures were observed.

Photograph 6: Outer plate after blister test up to 575 °C. The meat zone suffered large deformation without blister formation.
