CORROSION OF RESEARCH REACTOR AL-CLAD SPENT FUEL IN WATER

SUMMARY

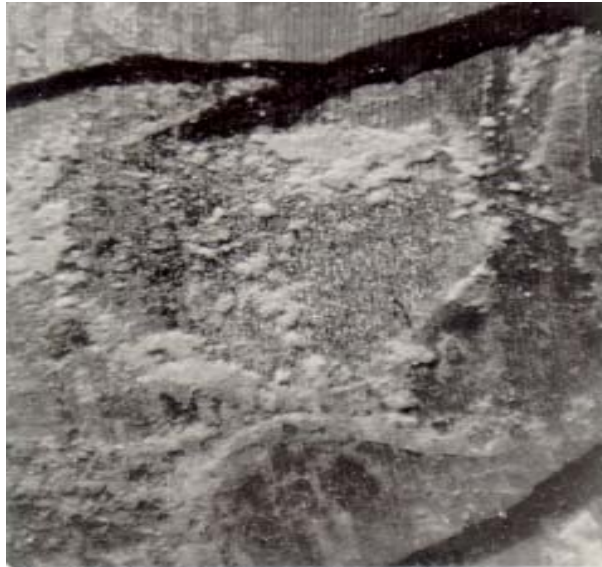
Fig. 7: Coupon 6064/64; crevice corrosion (18X)

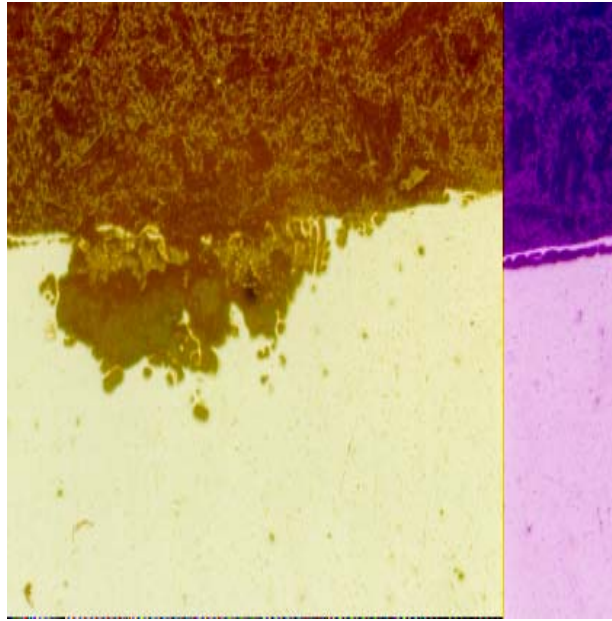
Fig. 8 Cross-section of an isolated pit 50X

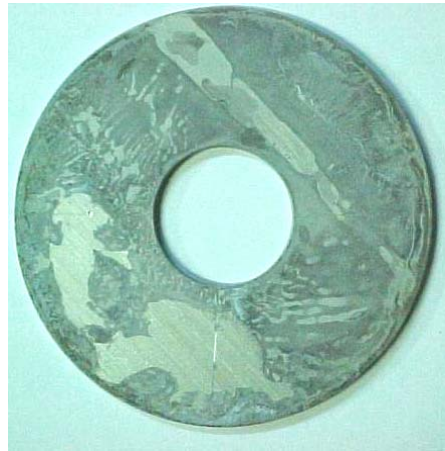
Fig. 9: Uneven oxidation (x 1)

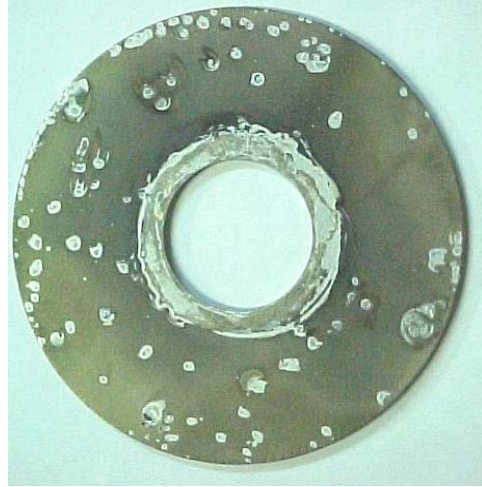
Some pitting was noted even in the high purity water of the RA6 reactor pool. This pitting was always associated with deposited particles. Pits, 1-2 mm in diameter were produced in waters with no detectable amounts of chloride or sulphate and with conductivity less than 2 $\mu\text{S}/\text{cm}$. The particles were thought to be iron oxide and were cathodic to the aluminium. Conditions inside some of the crevices resulted in oxide patches. Other areas seemed pickled, possibly by acidification of the water within the crevices. Small pits (0.1 mm in diameter) were found inside these crevices. Results of these investigations showed that the basin storage environment contained floating particles and it was not always possible to associate the degree of pitting with water composition.

Fig. 10: Pitted surface (x 1)

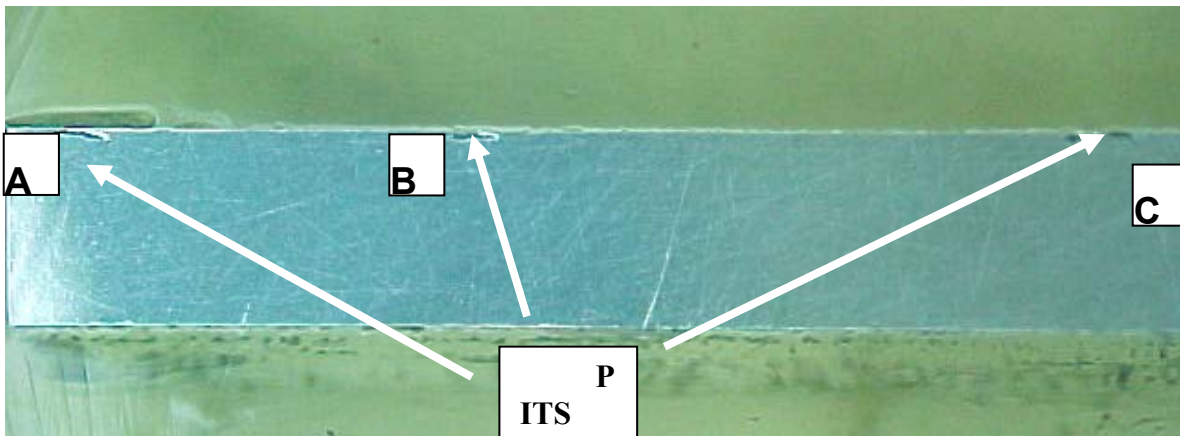
Fig. 11: Cross section of coupon revealing pits A, B and C. Coupon thickness: 3 mm

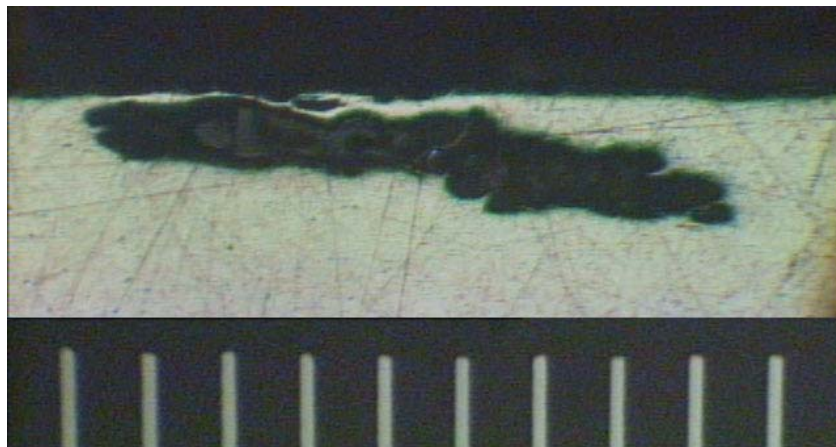
Fig. 12: Pit A from Fig.11 at higher magnification. One division equals 100 μm

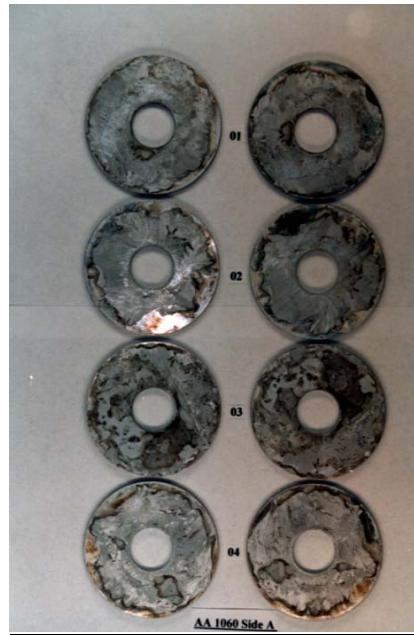
(a)

Fig. 13. Surface features on the facing surfaces of AA 1060/1060 crevice couple coupons and AA 1060/ AISI 304 galvanic couple coupons

stained inside the crevices, but not pitted as shown in Fig.13a. The stainless steel/aluminium galvanic coupons were much more severely corroded (Fig.13b). Additional laboratory tests were conducted to determine whether increased levels of silver (Ag) in the basin water could have increased the corrosion of the aluminium cladding in the IPEN basin. Results indicated no pitting, but an increase in darkness of the surface oxide colour with increase in silver concentration.

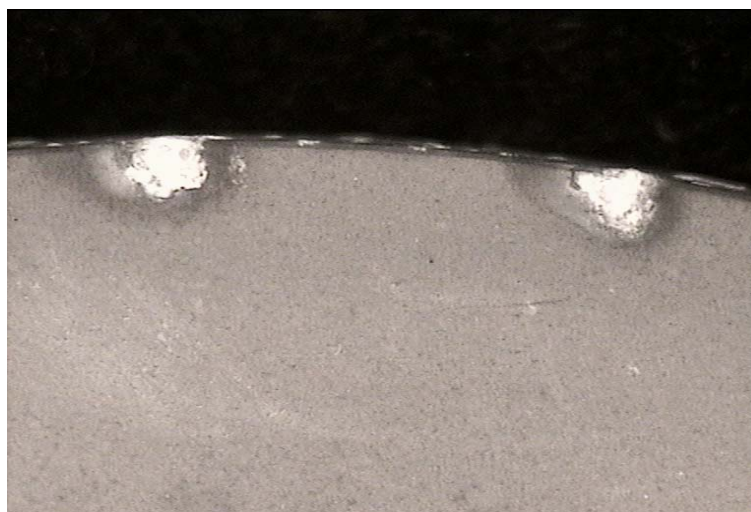
Five racks were immersed in the spent fuel storage pool, and included the rack given by the IAEA in 1996. The basin water was not constantly circulated and it was purified once a year using an ion exchange system. The conductivity of the basin water ranged from 3-10 $\mu\text{S}/\text{cm}$ and the chloride ion content <0.1 ppm. A dark grey oxide layer, from general oxidation, developed on most of the outer surfaces of the coupons in contact with the water. The colour darkened and the layer thickened with time. Crevice corrosion products formed in the crevices between coupons. No pitting was observed on coupon surfaces, but some pitting occurred on the outer rim of the coupons, due to edge effect.(Fig.14)

Fig. 14. Coupon of Rack-2 showing pits
