# **INSPECTION EXPERIENCE WITH RA-3 SPENT NUCLEAR FUEL ASSEMBLIES AT CNEA's CENTRAL STORAGE FACILITY**

Oscar Novara and Jose LaFuente  
Comision Nacional de Energia Atomica  
Buenos Aires, Argentina

Steve Large and Trent Andes  
Westinghouse Savannah River Company  
Aiken, South Carolina, USA

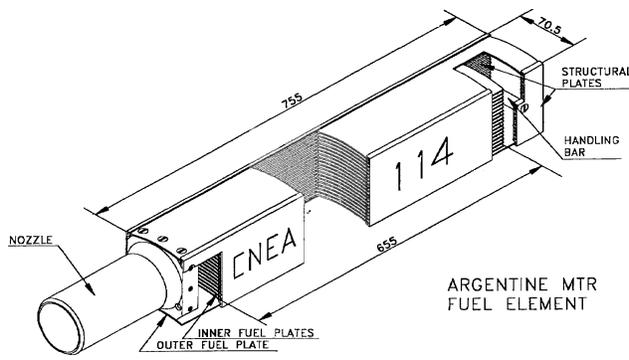
**Figure 1: RA-3 Fuel Assembly**

RA-3 assemblies are of the typical material test reactor (MTR) design with nineteen (19) curved fuel plates in each standard assembly (Figures 1 and 2). The fuel plates are aluminum clad uranium-aluminum alloy. The standard assembly has a lifting bail at the top and a flow nozzle at the bottom. Control assemblies have only fifteen (15) fuel plates, two vacant slots for insertion of neutron absorber plates, and longer side plates to accommodate controls for the manipulation of absorber plates. The stored assemblies are uncropped and range in length from 88 centimeters for standard assemblies to 161.1 centimeters for control assemblies. There are four (4) assembly variations (based on fuel loading) described in Table 1.

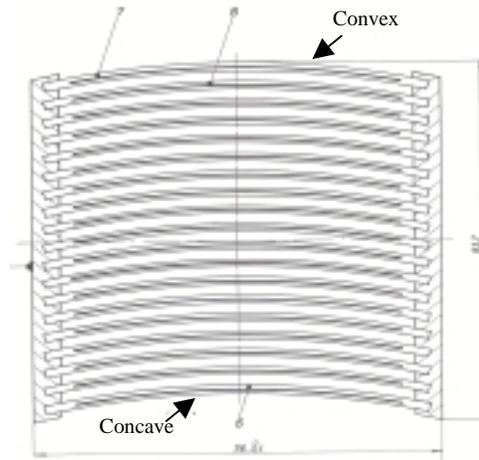
**Figure 2: Cross-Sectional View of Fuel Assembly**

Assembly cross sectional area is about 8.4 centimeters by 7.6 centimeters, and the fuel plates are roll-swaged to the aluminum side plates.

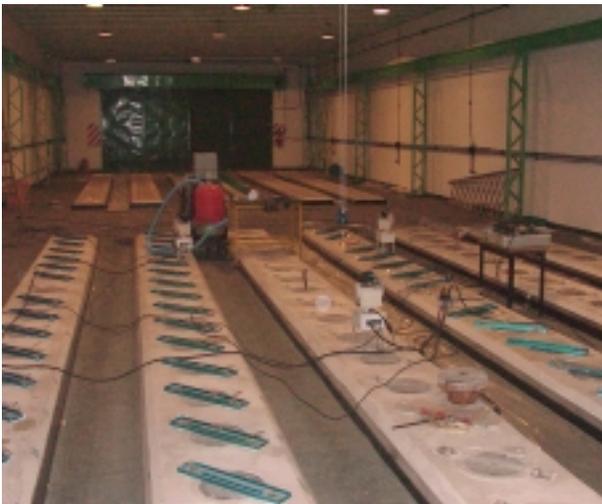
**Figure 3: Remote Cameras**

The best images were obtained with the above ground cameras located approximately 120 degrees apart and four to five feet from the dummy assembly (Figure 3). Pan, tilt, and zoom controls were provided for each above ground camera along with a display screen and a digital video recorder for each camera. These cameras were selected as the primary inspection tool with the intent of inspecting as many assemblies as possible by remotely raising each assembly out of the storage tube.

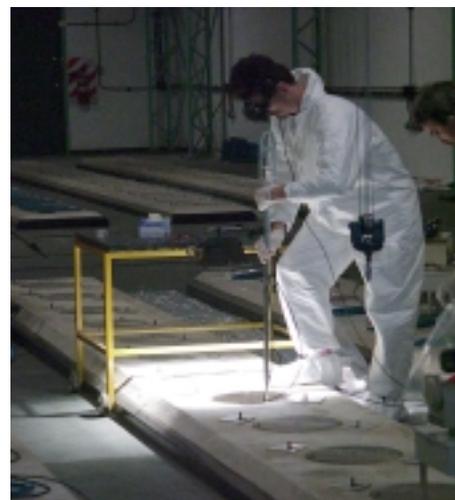
**Figure 4: Camera-equipped Grappling Tool and Video Goggles**

A small diameter, waterproof camera was installed on a grappling tool to aid in viewing and manually grasping lower assemblies in the storage tubes (Figure 4). The camera signal again was fed to video goggles worn by the fuel-handling operator. The camera-equipped grappling tool was used to manually raise the bottom assembly about 1 meter until the assembly could be secured with another lifting tool described below.

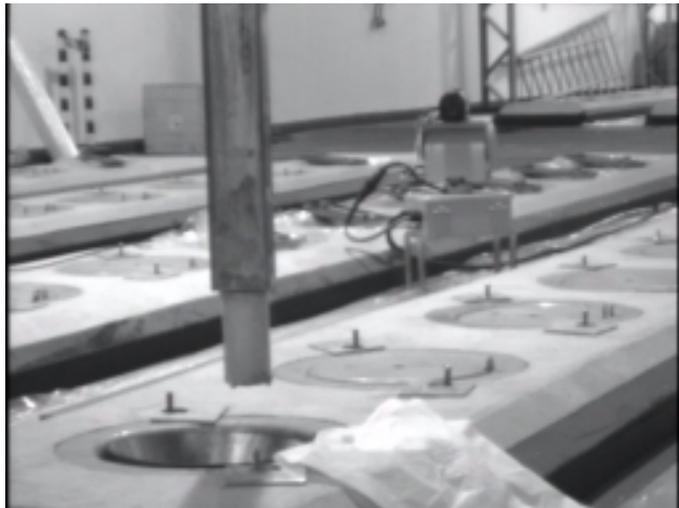
**Figure 5: In-Air Inspection**

1. Hands-on inspection and digital photography of six unirradiated assemblies.
2. Remote above grade video camera inspection of irradiated assemblies from storage tubes containing single assemblies. Each assembly was simply raised for inspection and lowered back into the tube afterward (Figure 5).
3. Remote above grade video camera inspection of irradiated assemblies from storage tubes containing two stacked assemblies. The top assembly was relocated to another storage tube after inspection to allow the lower assembly to be raised for viewing.
4. Video probe inspections of fuel assemblies that either could not be raised or required downward looking views.

The three above grade video cameras were typically positioned to provide clear views of both outer fuel plates and at least one side plate on each assembly after removal from the storage tube. Operators zoomed and focused each camera on the plate in view and panned up and down the full length of the assembly while recording the inspection on digital videotape. The inspection record for each assembly consisted of 4 to 6 minutes (7 to 9 minutes for the control assemblies) of videotape from the three cameras. Special emphasis was placed on recording the assembly identification numbers and any abnormal characteristics such as damage or excessive corrosion.

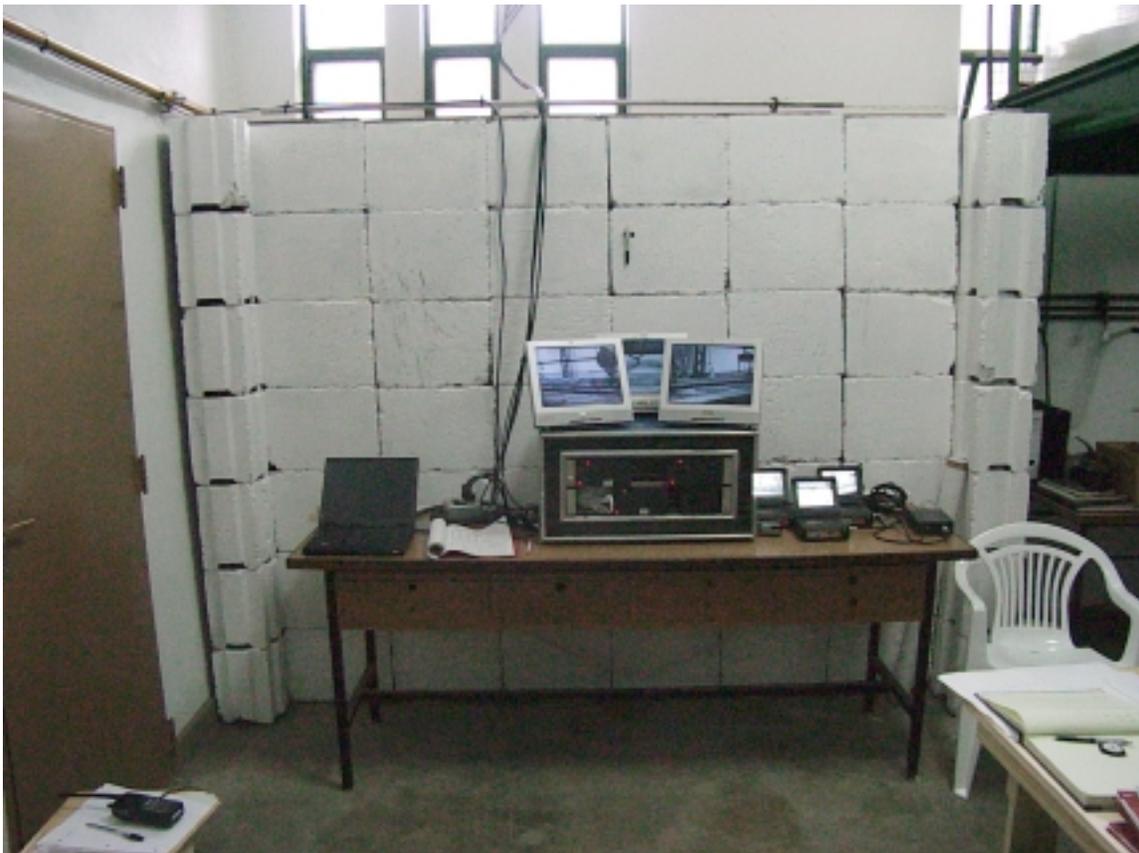
**Figure 6: Equipment Building Monitoring Station**

Some modifications were required to CSF equipment and facilities to support in-air inspections of fuel assemblies. A block shield wall was erected inside the Equipment Building to reduce radiation exposure at the camera control station. This building is approximately 10 meters from the CSF, and coaxial camera cables were suspended between the two buildings.

Facility personnel sheltered behind the monitoring and control station shield wall inside the Equipment Building or withdrew to a safe distance from the CSF while assemblies were in air (Figure 6).
