Acceptance Test of WCTC with LEU fuel

at the IVG. IM Research Reactor Site in Kazakhstan

RERTR 2022
International Meeting on
Reduced Enrichment for
Research and Test Reactors
October 3-5, 2022
Vienna, Austria

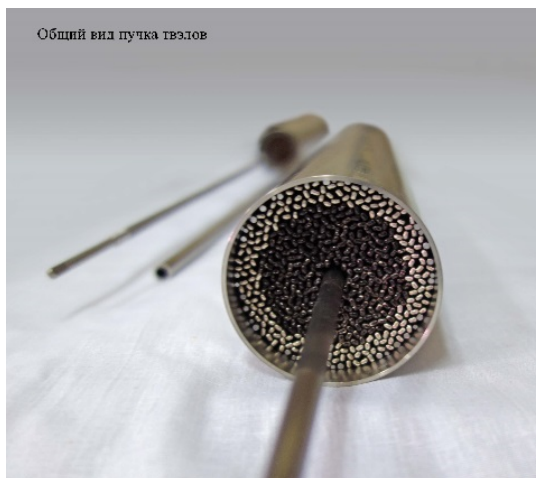
General view of the LEU fuel assembly

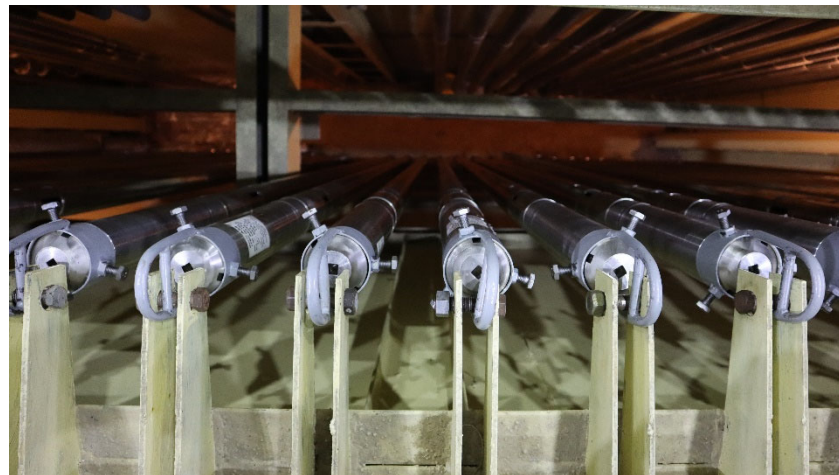
LEU fuel assemblies after inspection

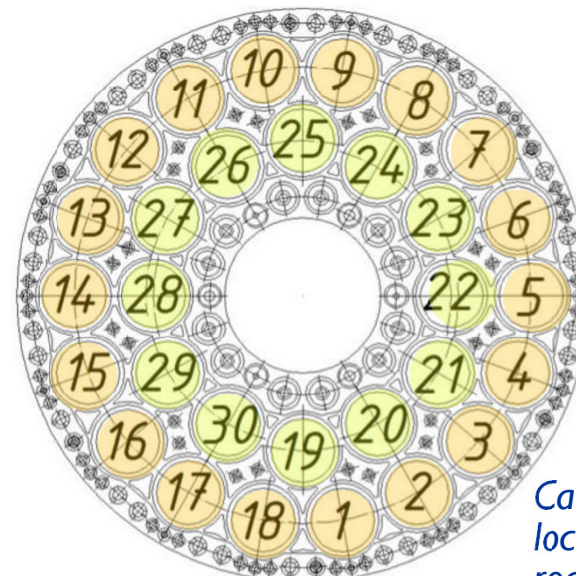
Cartogram of the WCTC location in the IVG.IM reactor's core

- WCTCs are located in two rings
- Length of fuel rods in WCTCs:
 - ✓ in outer ring 800 mm
 - ✓ in inner ring: 600 mm
