CORROSION OF RESEARCH REACTOR AL-CLAD SPENT FUEL IN WATER

SUMMARY

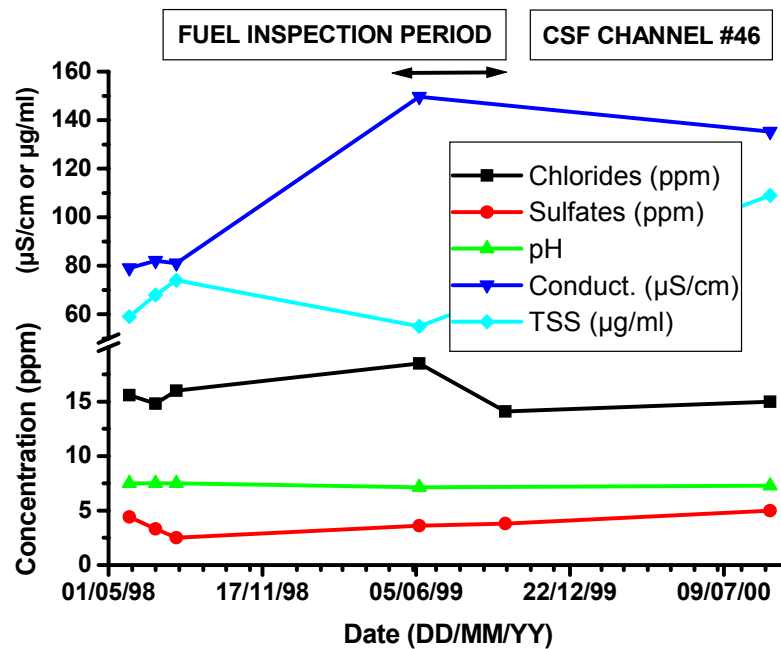
Fig. 5: Variation in water parameters in CSF #46

In mid-1998, six additional racks containing crevice and galvanic couple coupons were immersed at EFC, the RA3 decay pool, the RA6 reactor pool, and the RA6 decay pool. These pools provided a wide range of water chemistry conditions. Figs. 5 and 6 show variations in chemical parameters of the EFC and RA3 decay pool waters with time. The conductivity ranged from 227 $\mu\text{S}/\text{cm}$ in the EFC down to 1.8 $\mu\text{S}/\text{cm}$ in the RA6 reactor pool. The chloride ion content ranged from 16 ppm in the EFC to less than 0.5 ppm in the reactor pool. The racks immersed in the different basins contained coupons provided by the IAEA and aluminium alloy coupons used in the manufacture of Argentine fuel. Racks were immersed in the basins in mid-1998. Some were removed and examined in August 1999 and others in February, July, and September 2000. Severe pitting and crevice corrosion was noted on most of the aluminium coupons in the EFC, where the water was most aggressive. Much of the pitting on the external surfaces was caused by deposition of what was thought to be iron oxide particles from the corrosion of the carbon steel cover plates. Fig. 7 shows a coupon surface with crevice corrosion products and Figs. 8-12 the surfaces and cross-sections of different pitted Al coupons
